Six Monthly EC Compliance Report

Period : April to September, 2017

Unchabali Iron & Mn Mines

Combined Six Monthly Compliance Status of Environmental Clearance Conditions – "Unchabali Iron and Manganese Ore Mines & Iron ore Beneficiation Plant of M/s Indrani Patnaik" located in village(s) Unchabali & Balda, Sub-division Champua, District Keonjhar, Orissa.

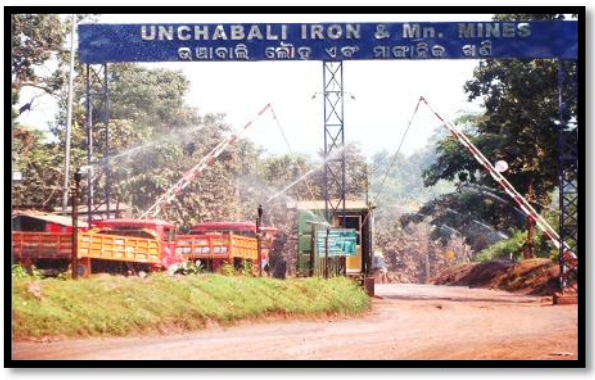
PHOTOS -4:

Photos showing mobile water tankers encaged for dust suppression
